**PHASE I ENVIRONMENTAL SITE ASSESSMENT**

## **EI MONTE SAND MINING PROJECT**

**El Monte Valley  
Lakeside, California 92040**

## **ROYAL ENVIRONMENTAL SERVICES, INC.**

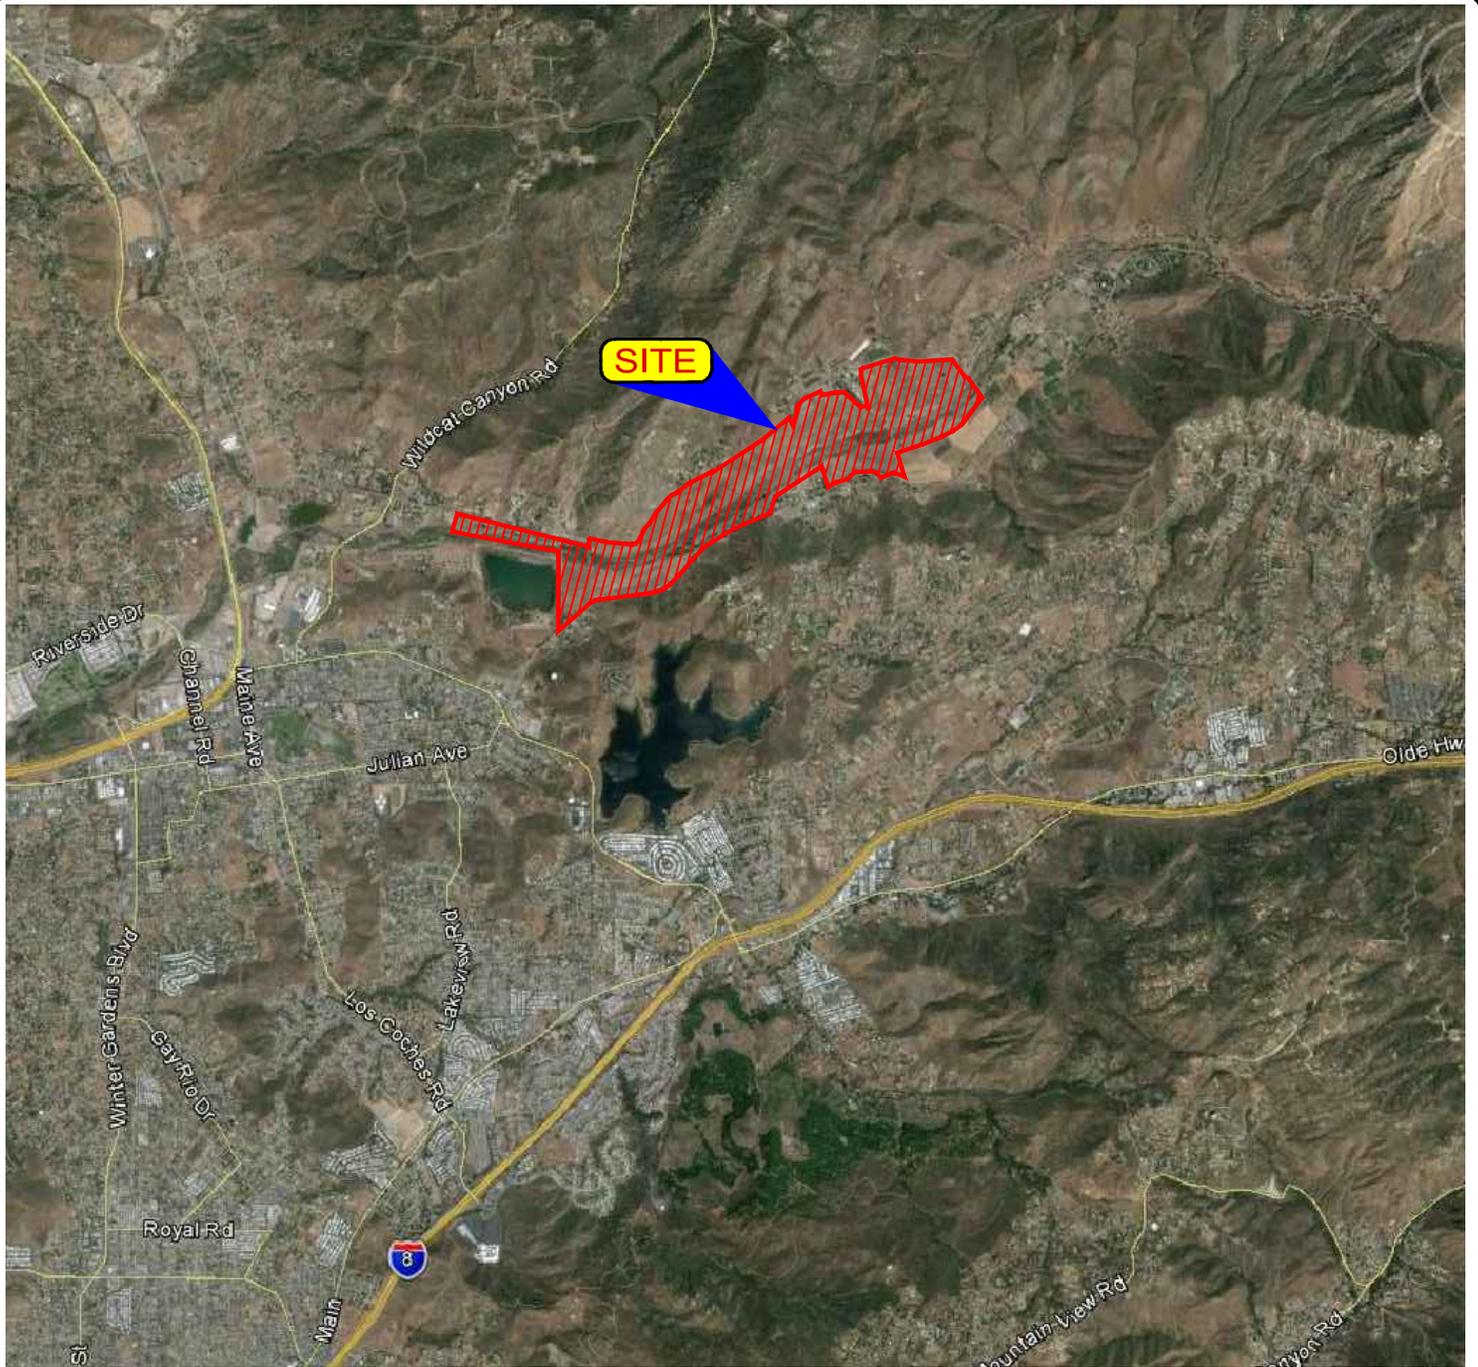
**1**

**SITE LOCATION MAP**

EL MONTE ROAD  
 LAKESIDE, CALIFORNIA

The subject site is part of El Monte Valley located between Willow Road on the north and El Monte Road to the south. The site is approximately 15,000 feet in length along the river beginning near Ashwood Street on the west and ending near Hazy Meadow Lane on the east. The site is approximately 650 wide at its narrowest on the western end and varying from approximately 1,300 to 2400 feet in width in other areas of the site. The site is in a transitional area between suburban and rural area of Lakeside, California (Figure 1).
